The Ruins
Virginia Water
Past and Present

WINDSOR
GREAT PARK

The Royal Landscape

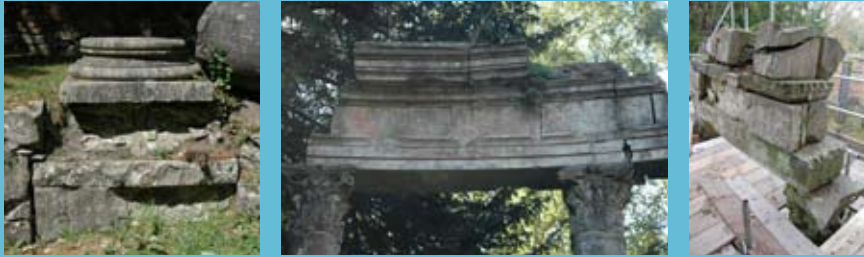
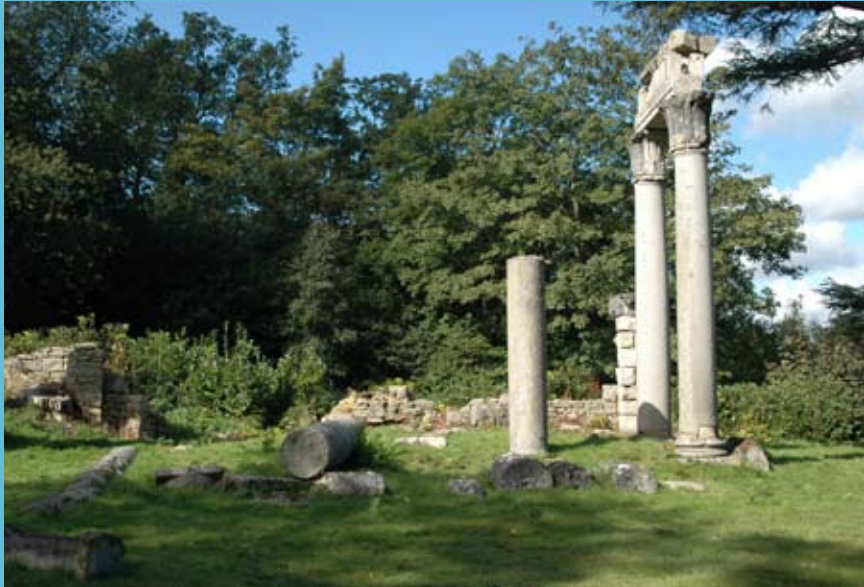
1. A damaged column base
2. The cracked lintel of the four-column apse
3. Failing stonework to the entablature
4. The west range before repair

Most significantly, two of the three largest columns which formed a 'portico' grouping in the southeast range had been taken down. This was carried out on the instruction of Queen Victoria in 1897 because of concern about the stability of the structure.

In the 1950s, one further column fell and several sections of entablature were displaced. Other columns had been toppled by vandals and visitors.

There were several areas of collapse to the enclosing side walls that were caused mostly by unchecked ivy and plant growth.

Iron clamps used in the original construction had also rusted, causing damage to the masonry and the collapse of at least one arch in the northwest sector.

The repair approach adopted was one of compromise between minimum repair, i.e. enough to conserve the monument in damaged condition and to prevent further deterioration, and full reinstatement, including reproduction of all missing statuary and building elements, to recreate the monument as envisaged by Wyattville.

As a first step invasive vegetation including ivy and self seeded tree saplings were removed and the ground level, which had been raised over the years due to leaf fall and plant growth, was reduced to its original level, revealing previously lost low walls and steps.

The collapsed walls have been rebuilt where it was clear that the damage was either accidental or deliberate, and not part of the original ruin.

All the columns that were known to have fallen were re-erected, and made more secure using modern fixing methods.

The three-column portico and its highly ornate entablature was re-erected.
